Fluorescent Aerosol Screening Test (FAST) Test Report

RTI International

January 7, 2015

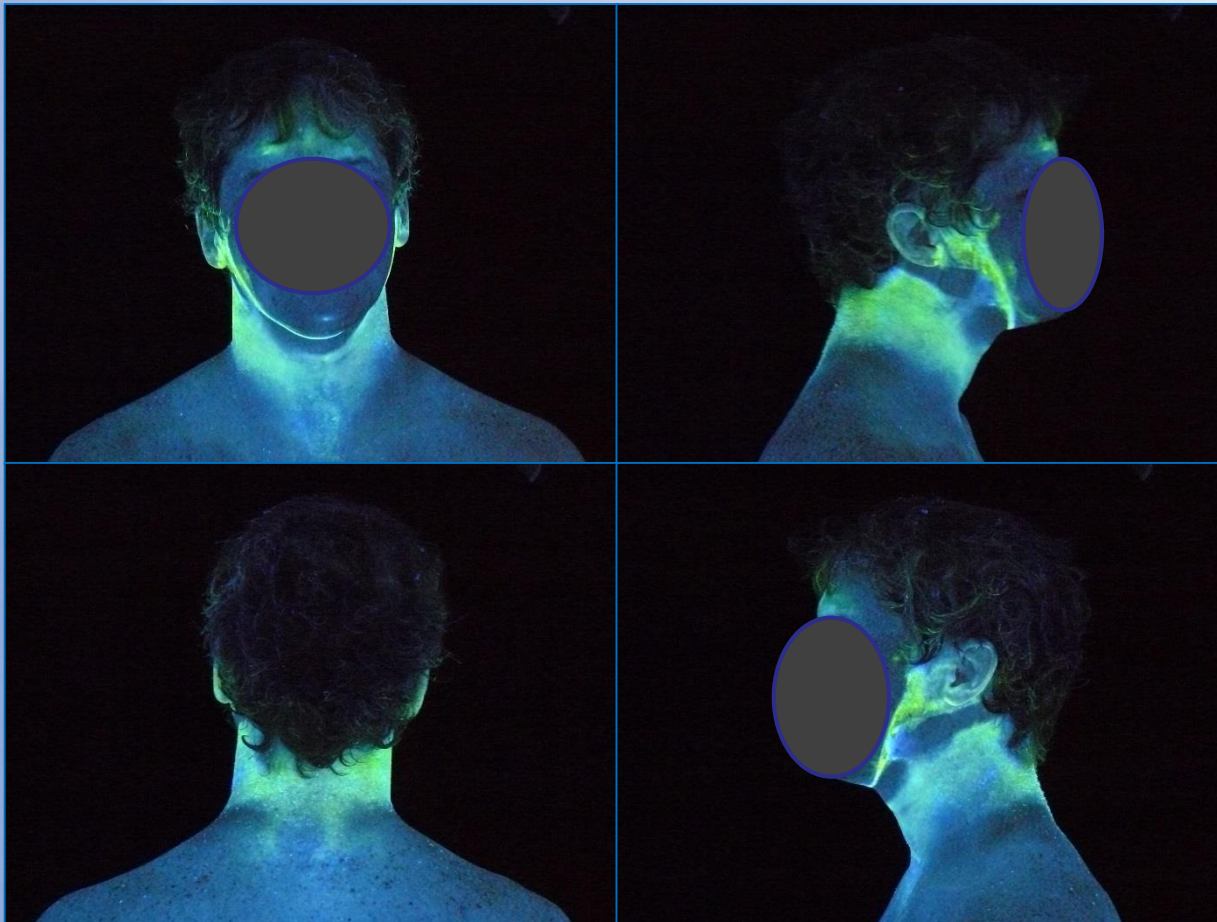
UV Photos: Head and Neck (Test # 2225, TP #7)

There were very heavy aerosol deposits on the neck, cheeks, ears, and hair due to penetration through the hood. The dark bands below the ears were relatively clean areas that were covered by the mask straps.
