Fluorescent Aerosol Screening Test (FAST) Test Report

RTI International

January 7, 2015

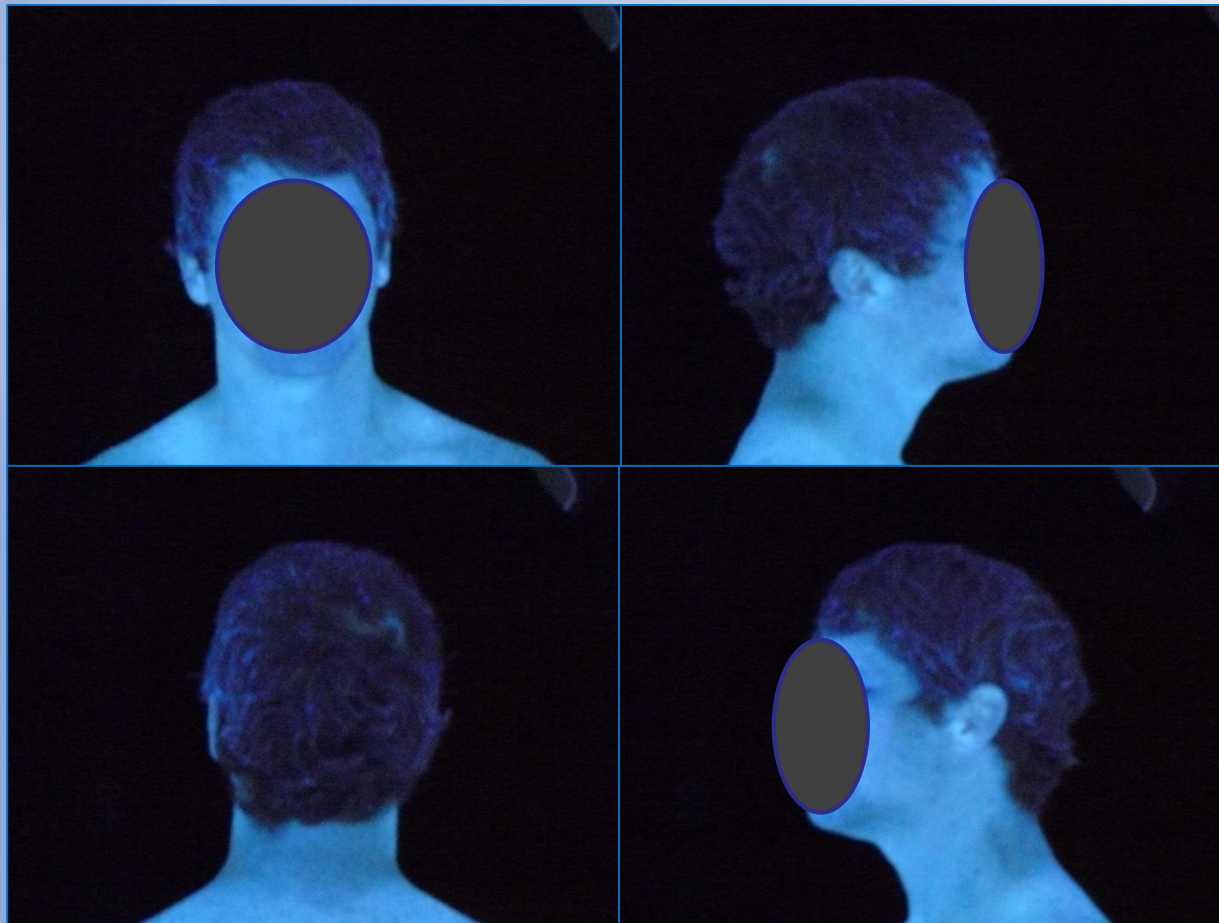
Background UV Photos (Test Participant #7)

The background photos confirm the test participant was clean prior to donning the test garment.

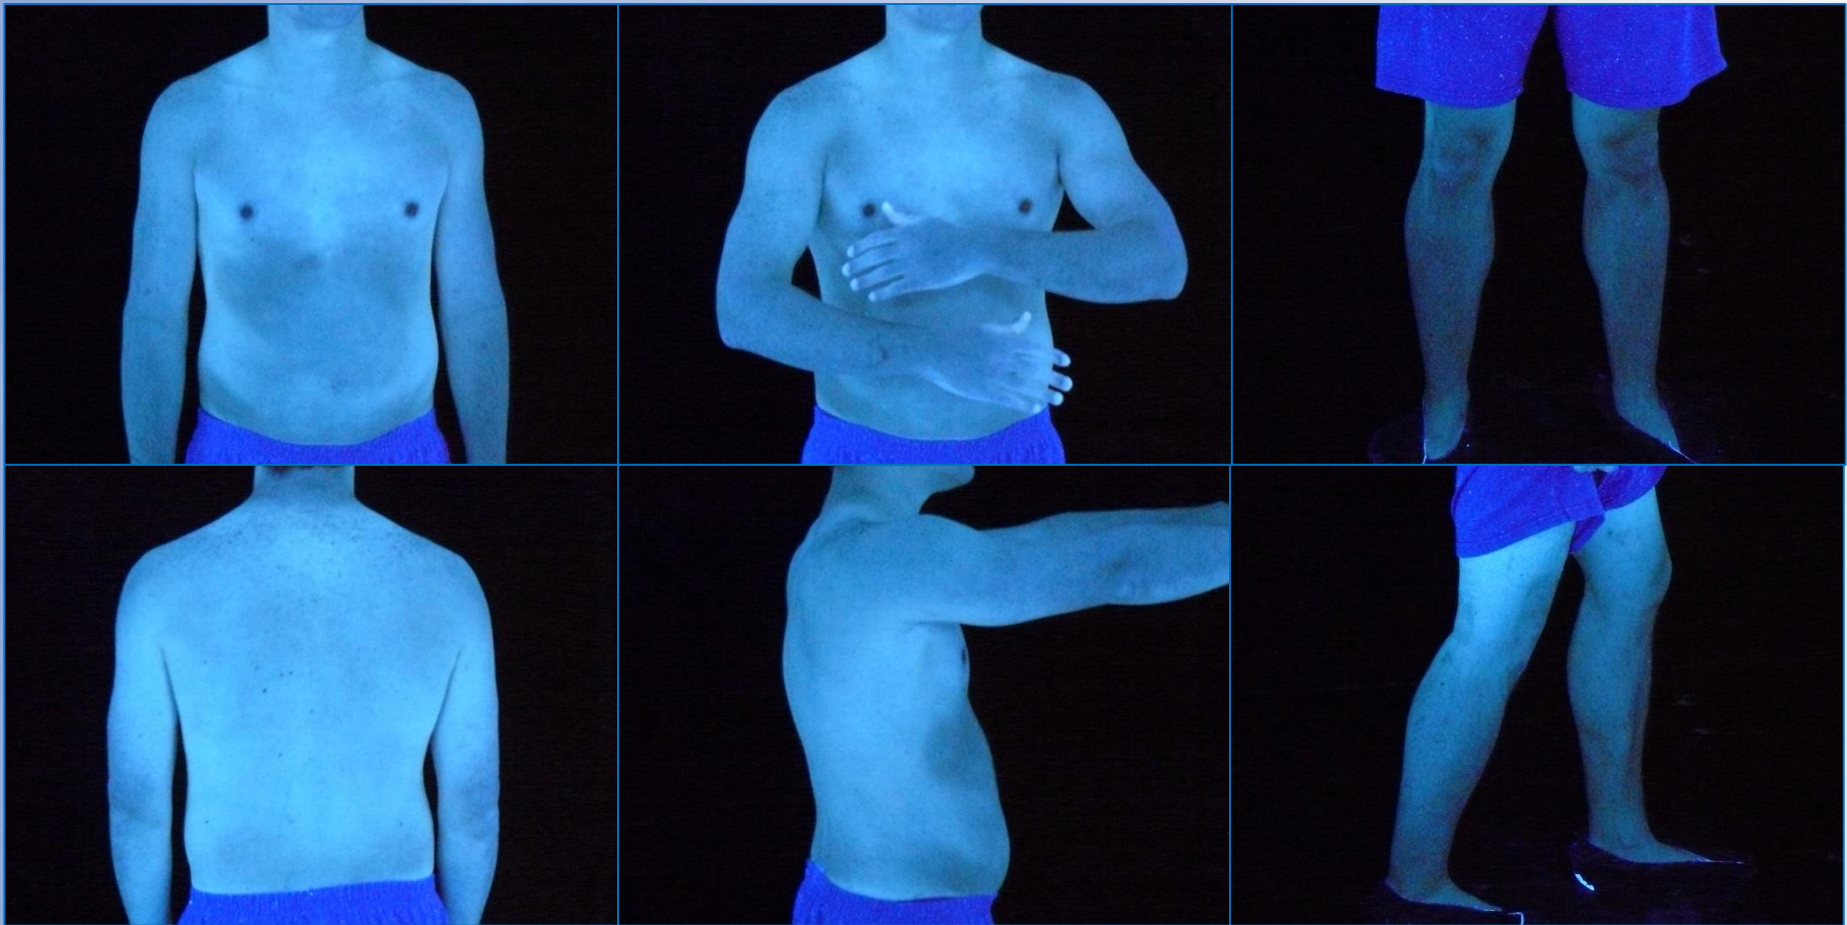
Background UV Photos (Test Participant #7)

The background photos confirm the test participant was clean prior to donning the test garment. Variations in skin brightness seen in these photos are due to natural skin fluorescence.

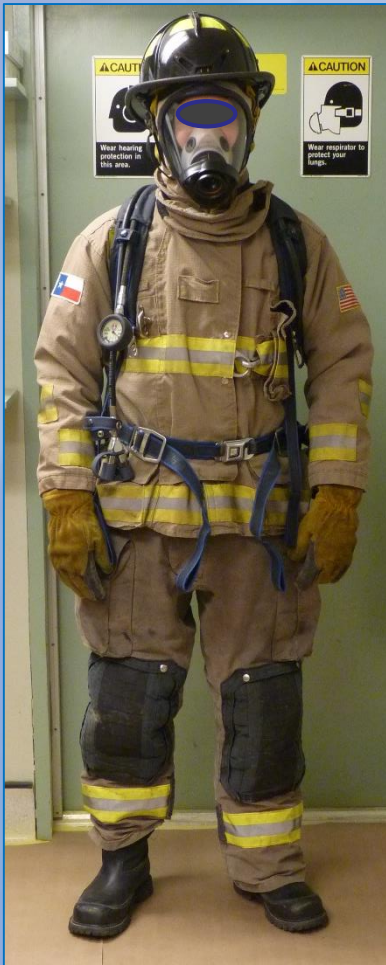
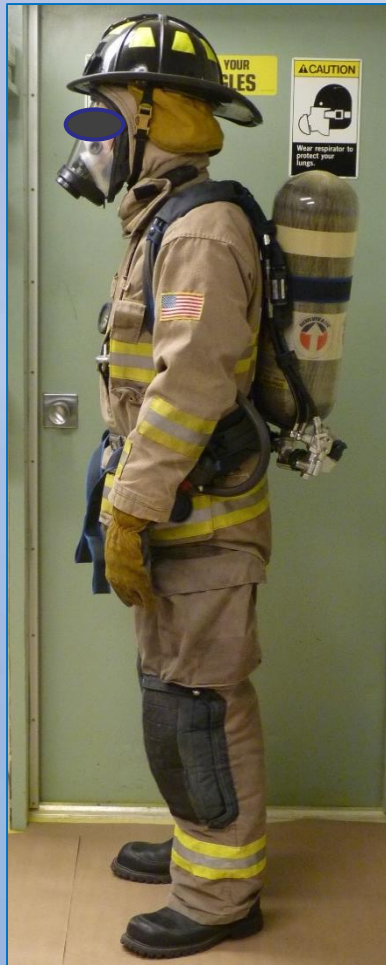
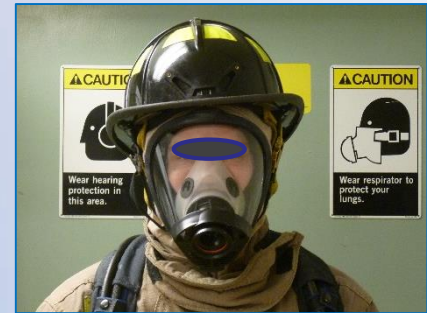
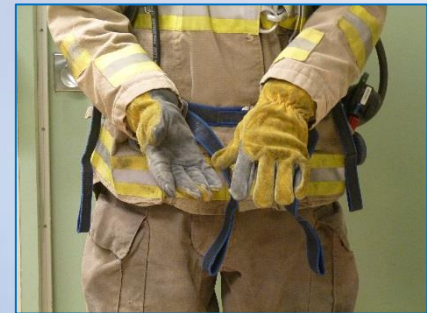
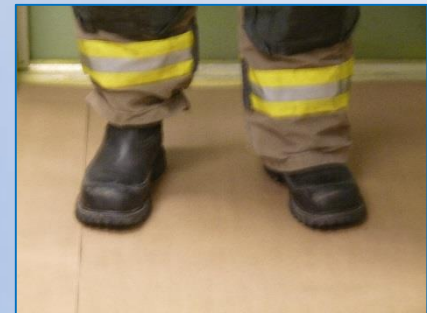
Pre-Test Photos (RTI Test # 2225)

14 Pre-test photos were taken prior to wind tunnel entry. To preserve air in the tank, the SCBA regulator was not connected until immediately before wind tunnel entry.
